Preliminary Investigation Report

Puget Sound Refinery East Flare Decontamination Odor Event

Report Date: February 21, 2015 16:00

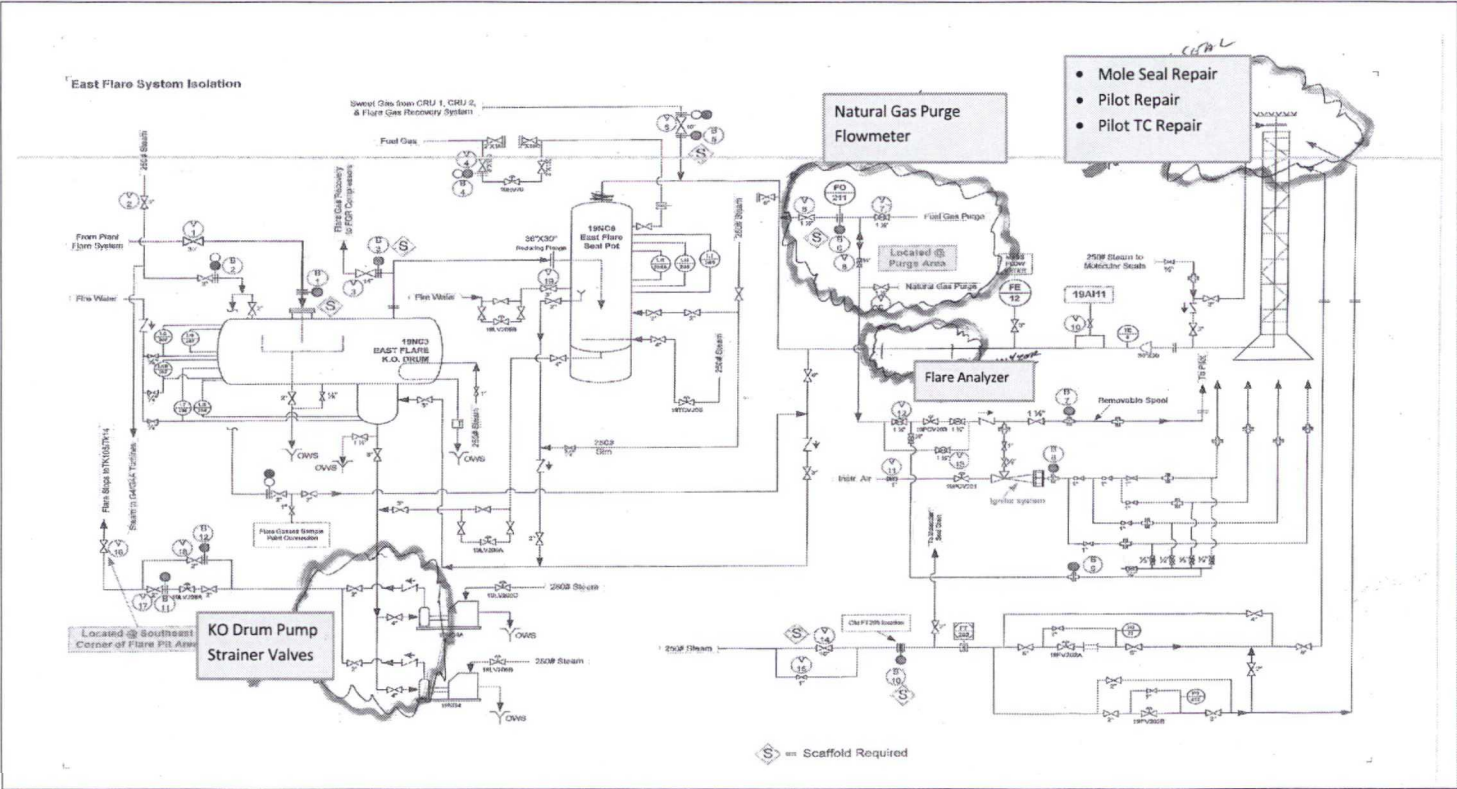
Appendix A: East Flare System Isolation

This drawing also identifies the work to be completed on the flare during this outage.
